Elwha River Restoration Project Update July 25, 2014

**SAC Meeting
Port Angeles, Washington**

Olympic National Park

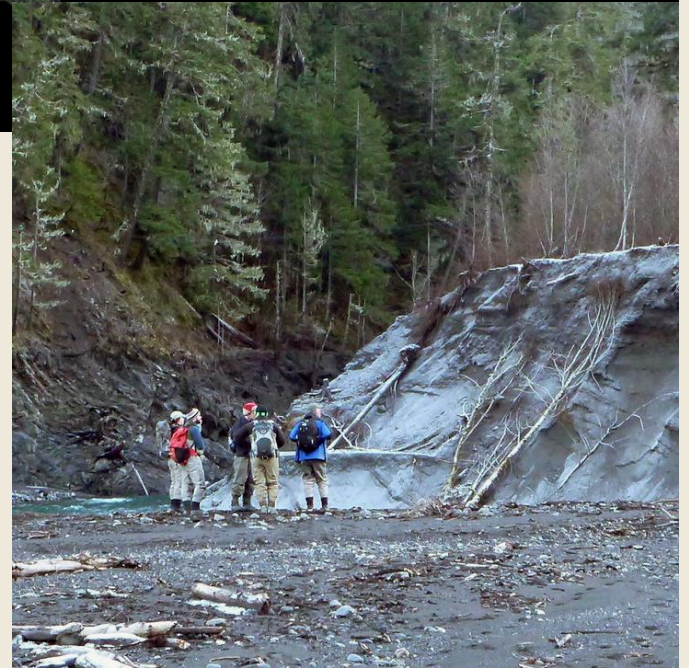
Estimated Total Sediment: 27 million cubic yards \pm 4 million cubic yards

Lake Mills Sediment:

- 21.1 million yd³
- $\frac{1}{2}$ clay and silt
- $\frac{1}{2}$ sand and gravel

Lake Aldwell Sediment:

- 6.4 million yd³
- $\frac{2}{3}$ clay and silt
- $\frac{1}{3}$ sand and gravel

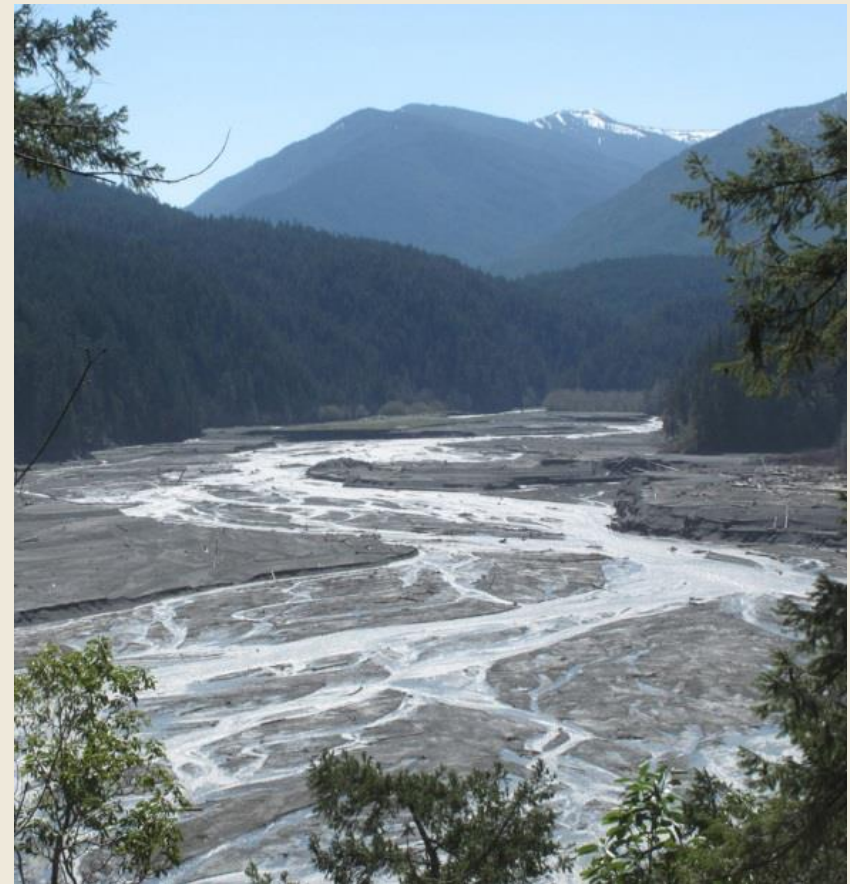
Sediment Management Plan

- Remove both dams in controlled increments and allow the river to erode a portion of the reservoir sediments to the sea.
- Rate of dam removal was designed to be fast enough to limit impacts to a few year classes of fish, but slow enough that downstream impacts can be tolerated.

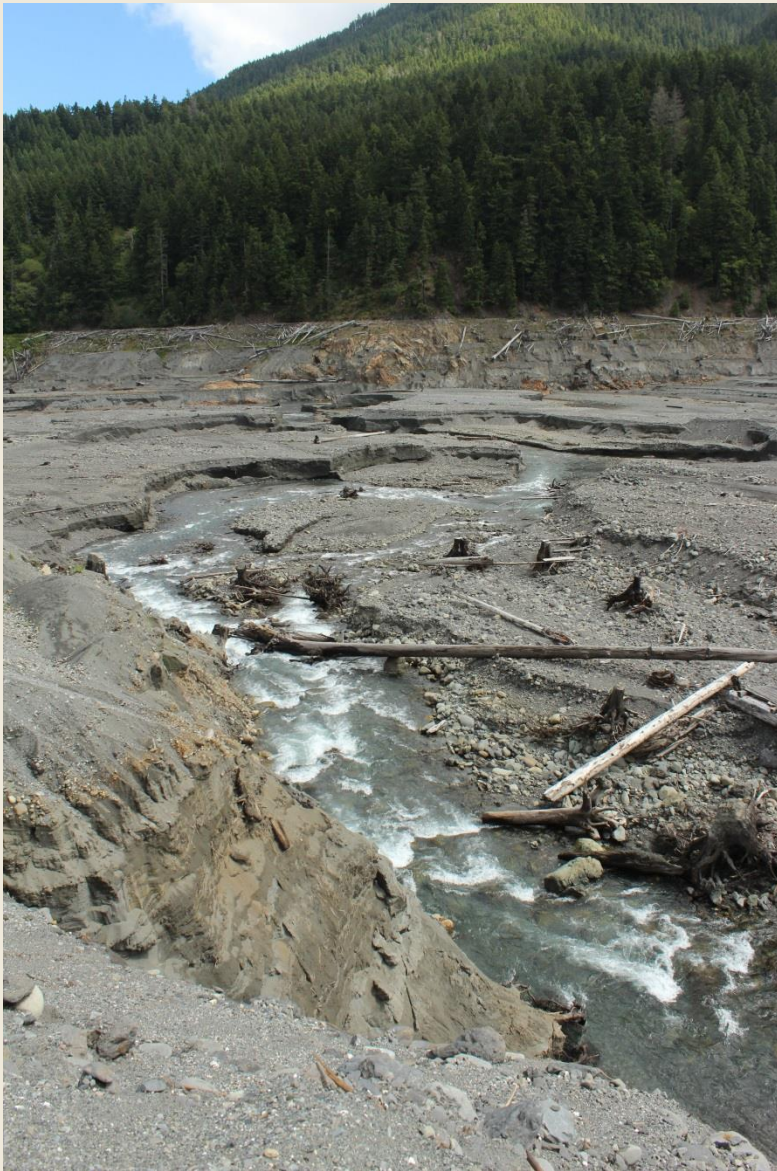
So far, 12.2 ± 0.1 million cubic yards has been eroded through July 2014.

In Lake Mills, 10.2 million cubic yards net erosion.

In Lake Aldwell, 2.0 million cubic yards since September 2011.

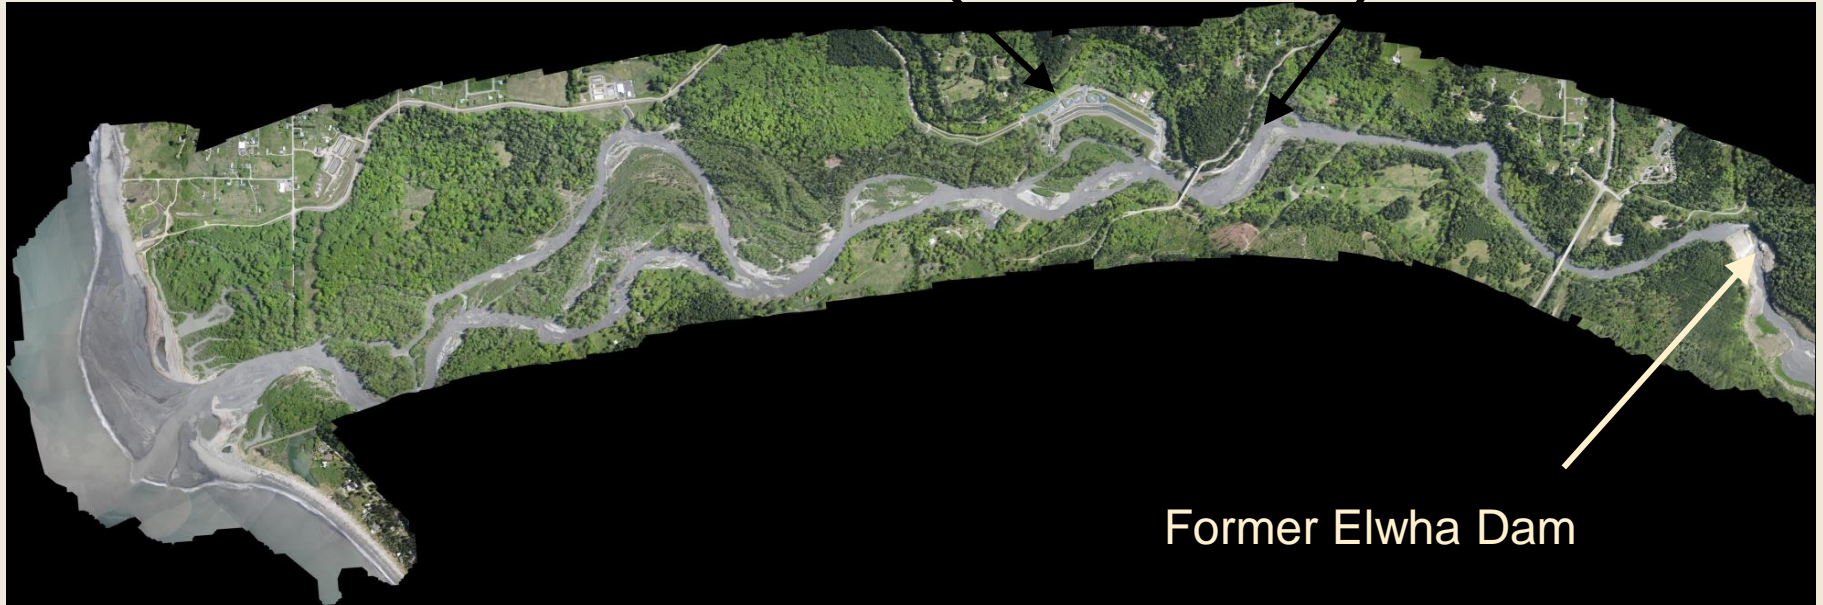
Elwha Water Treatment Plant

Elwha Surface
Water Intake

Former Elwha Dam

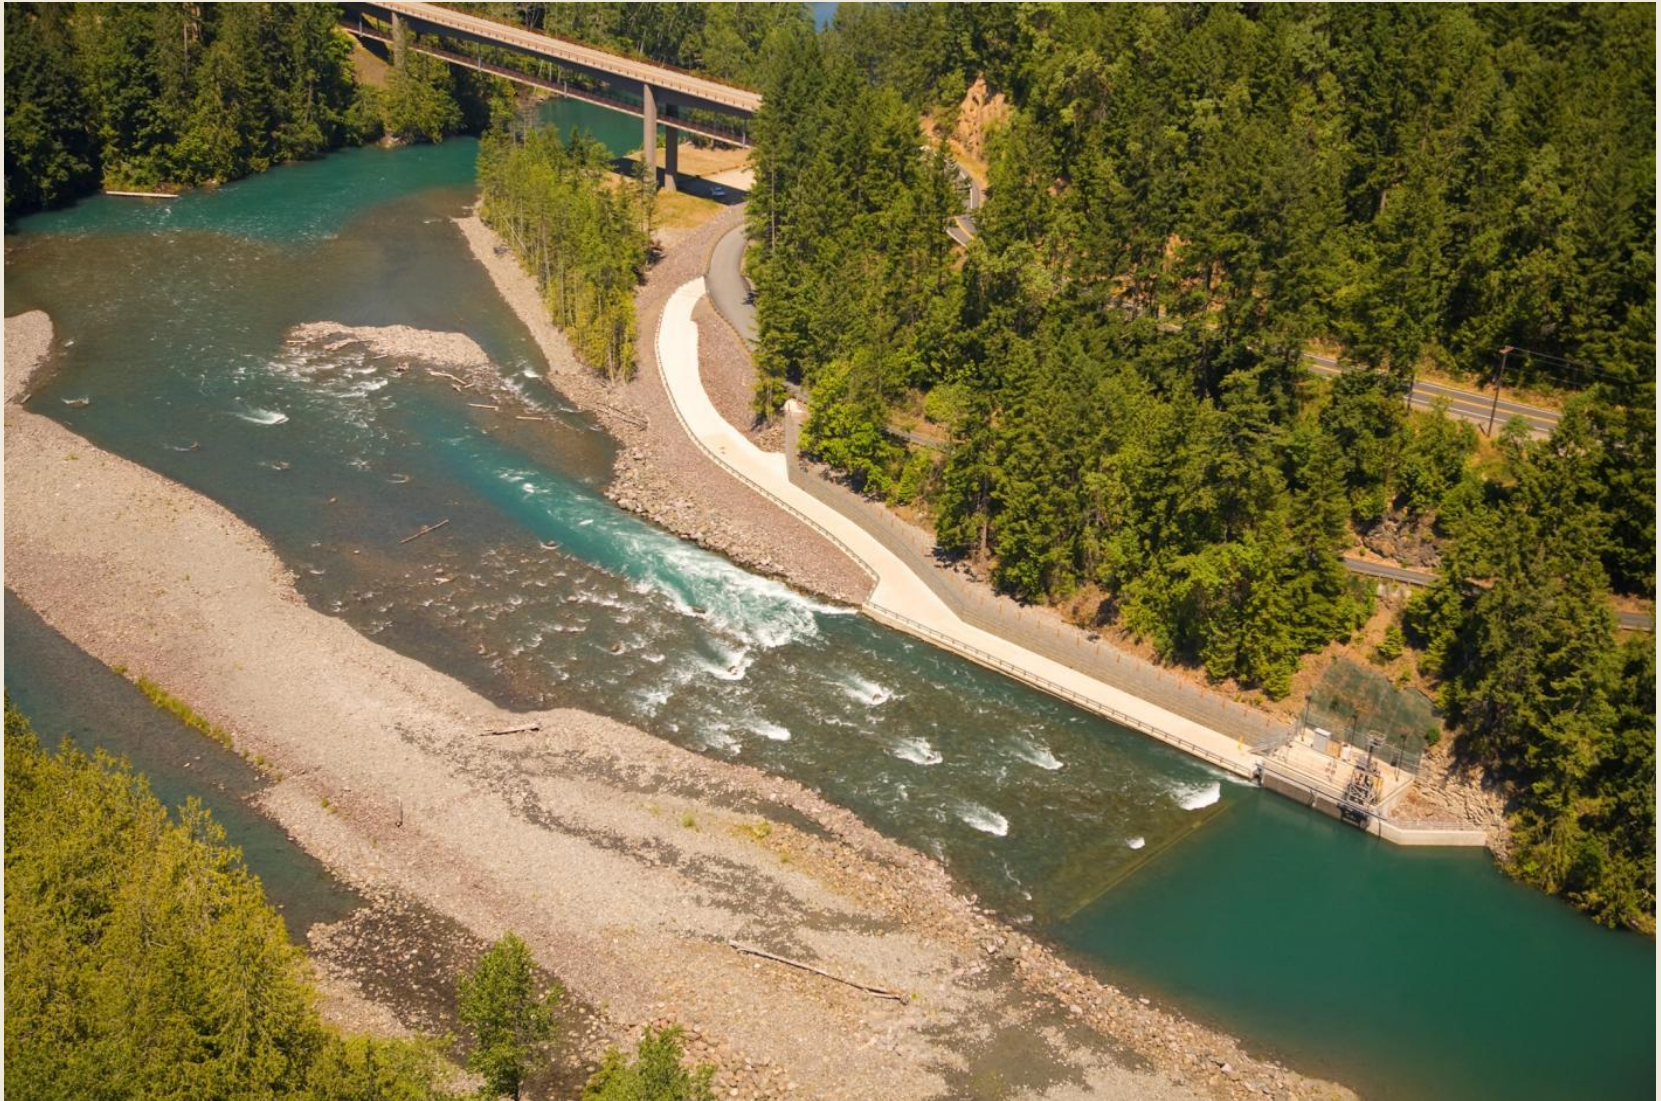
Elwha Water Facilities

Elwha Surface Water Intake
